COMMON BOND

Volume 18, No. 1 and 2
Fall - Winter 2003

Restoring Scagliola to Glory

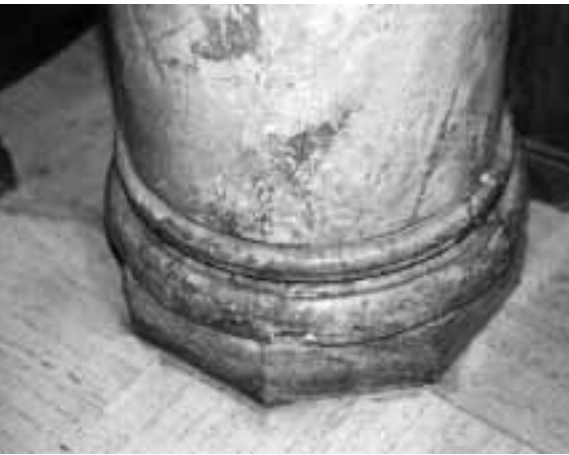
Cracking and staining are frequently found in surveys, as shown on the shaft and bases of green scagliola columns at Holy Trinity.

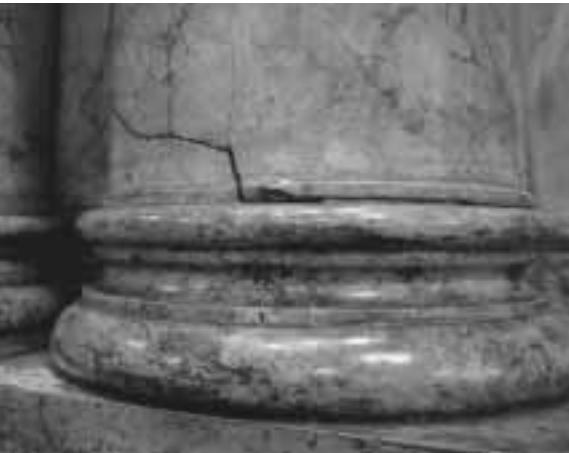
Scagliola columns with horizontal crack. St. Jerome's Church

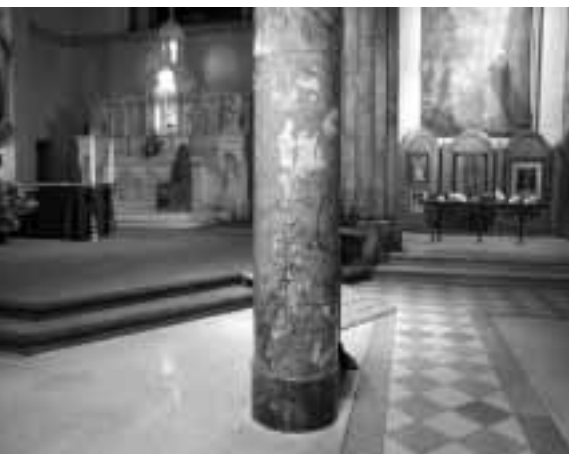
Scagliola columns with a failed, discolored coating at the Church of the Ascension

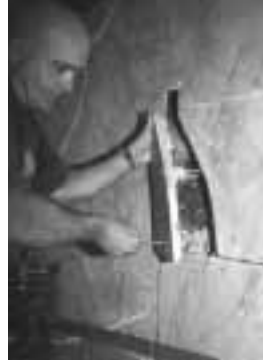
Right: Large, unstable cracks are channeled out to a V-shape and patched with infill.

To repair large, unstable cracks, craftsmen carve V-shaped grooves around the cracks, then fill them in with plaster. Scagliola is painstakingly applied to continue the pattern and veining that surrounds it. Colors are "touched in" over small repaired cracks with artist's brushes. Loose scagliola around cracks and patches can be reattached using plaster consolidation and adhesion techniques. Sanding, honing, and polishing is crucial to making patches or infill blend in.

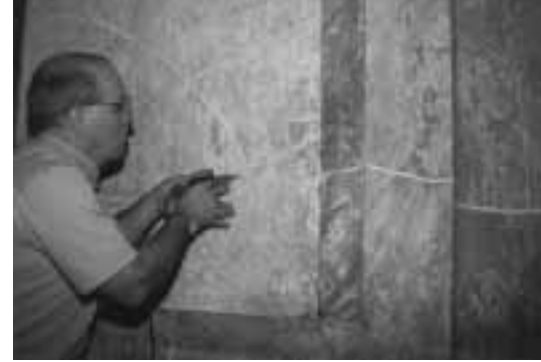
Unstable scagliola at risk of detaching and falling is the first priority for repairs.

Structural conditions where scagliola is at risk of coming off a wall or column are the first priority for repairs. The first step is to secure adjacent sections with tape or straps that won't scratch or rust, then temporarily remove the detached section. After cleaning out loose debris and preparing the substrate, the material is mechanically reattached by pinning and followed by crack repair and refinishing. Small pieces of scagliola, such as cracked wainscoting, can also be reattached with stainless steel pins.

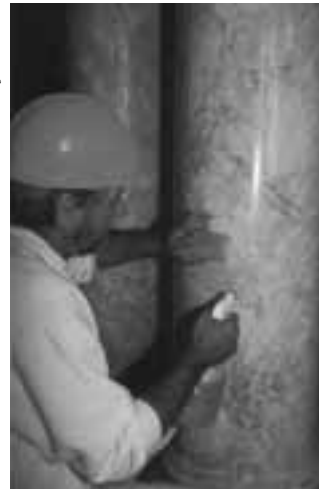
Scagliola is painstakingly applied to continue the pattern and veining that surrounds it.

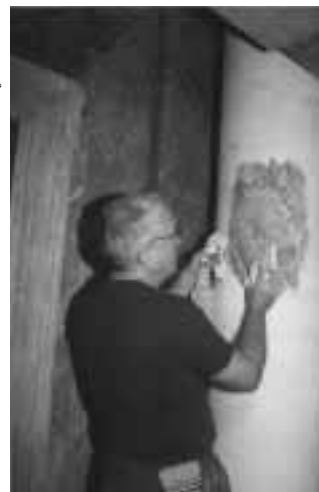
Sanding, honing, and polishing are crucial to making patches or infill blend in.

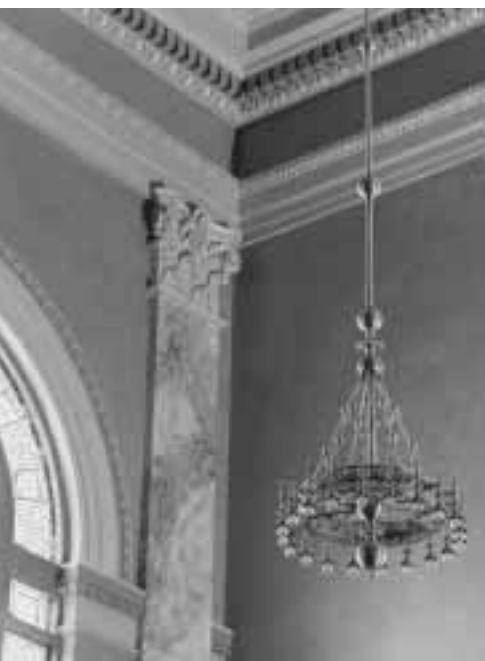
Scagliola pilasters at Congregation Shearith Israel after structural repairs and refinishing by EverGreene.

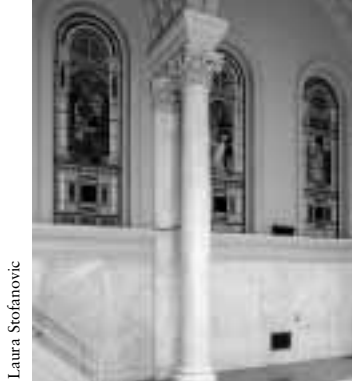
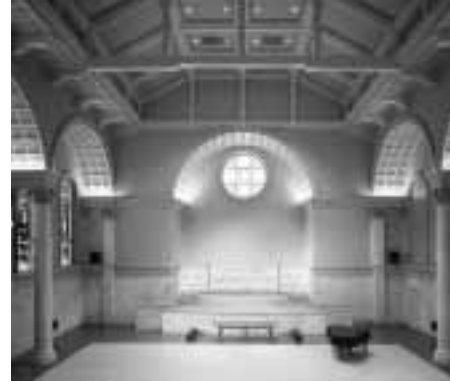
Imitation porphyry columns at Judson Memorial Baptist Church in Greenwich Village were stripped of overpaint, patched, and polished by EverGreene in 1998.

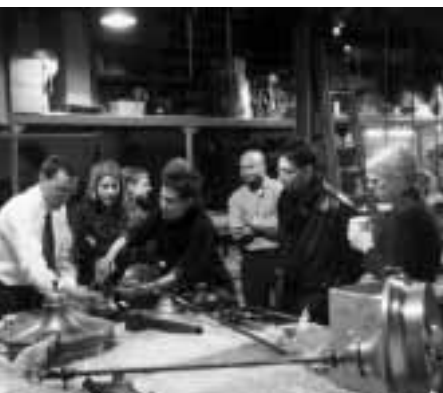
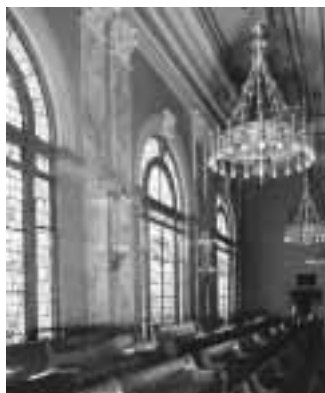
The elaborate lamp fixtures – during and after restoration.

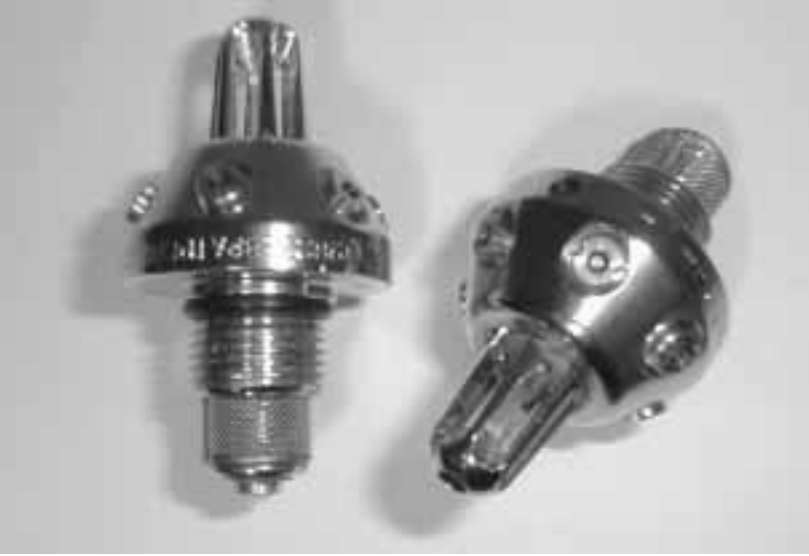
HI-FOG SPRINKLER

At the heart of the HI-FOG technology is the patent protected HI-FOG sprinkler, comprising a mounting adapter, sprinkler body, spool valve, water filter, nozzles and a breakable glass bulb.

The system consists of heat-sensitive bulbs that “pop” when heated by fire, opening water mist nozzles. Then water is delivered at very high pressure through stainless steel tubing, and the nozzles themselves atomize the water into a fine mist, which quickly fills the space immediately around the fire only, displacing oxygen, and putting out the fire. More than half a dozen bulbs can pop at once without significantly reducing the atomizing pressure.

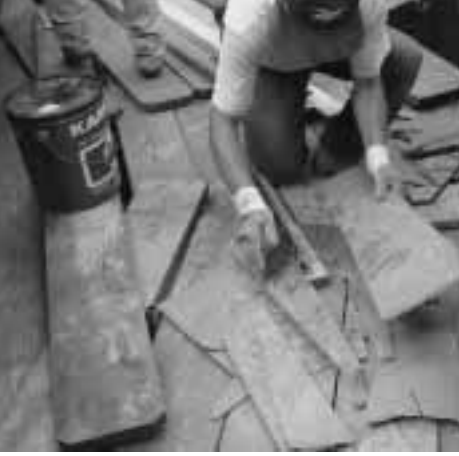
Slate workers cut slate tiles, then place them on the roof over waterproofing.

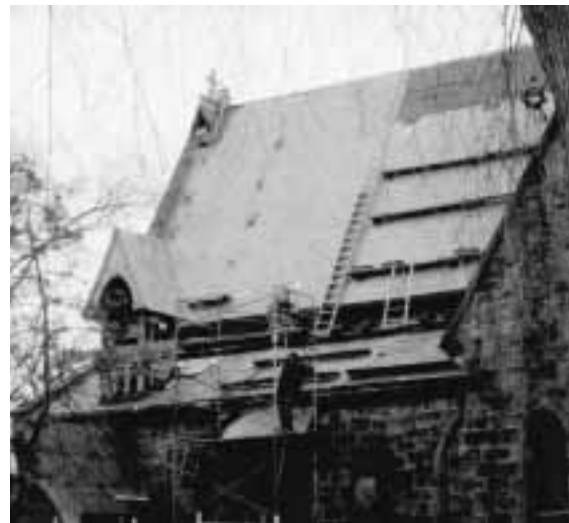
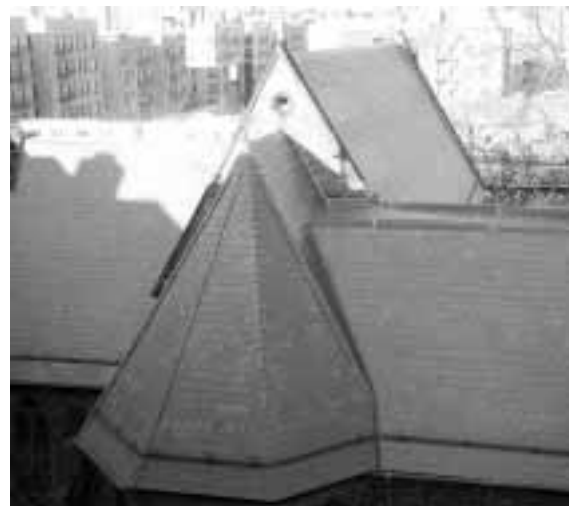
The work in progress and the final result.

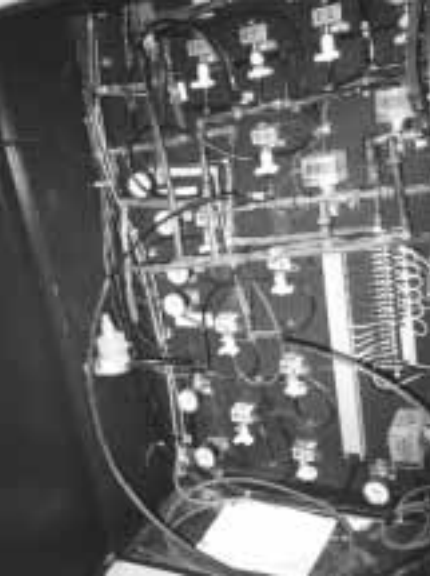
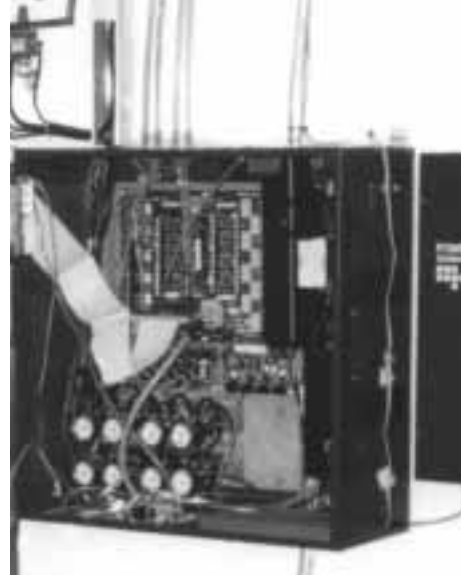
These temperature controls are in a 32,000 square foot church in suburban Philadelphia. The pneumatic system on the right uses compressed air to control temperature in ten zones. On the left is a digital energy management system to control the pneumatic system. To change the temperature schedule, you need a computer with a modem.
