# COMMON BOND

Volume 19, No. 1  
Fall - Winter 2004

Volume 19, Number 1 *Fall-Winter 2004*

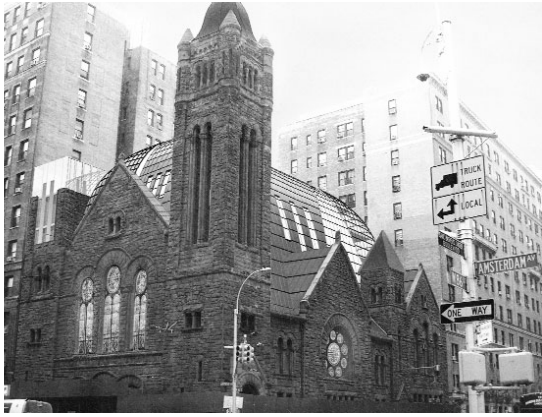
*As the fate of West-Park hung in the balance, Friends presented this preliminary design that expands program space while preserving the historic structure.*

The group was able to develop alternatives that would keep the church in the community and preserve the historic building. The group proposed an adaptive reuse that would create additional income and identified non-profit organizations that could be tenants and co-developers. Paige Ayres Cowley, an architect and life-long neighborhood resident, was hired by the group and created a design for an expanded and modern building that incorporates the historic facade, along with a strategy to keep pastoral and community-based programs operating during construction. Most importantly, Friends of West-Park negotiated substantial financial commitments from neighboring co-op residents to support the new design.

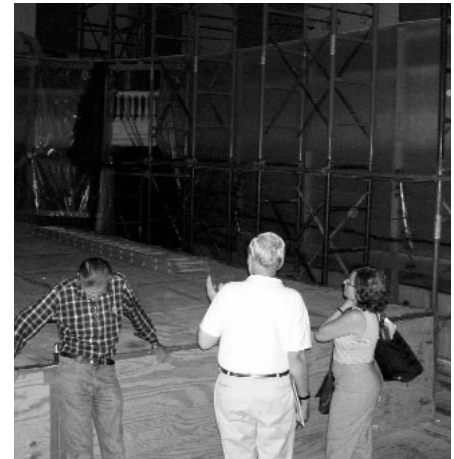
*Dave Elligers and Robert Buonvino, president of the New Utrecht Historical Society, inspect shoring at church interior with Ann Friedman of the Conservancy.*

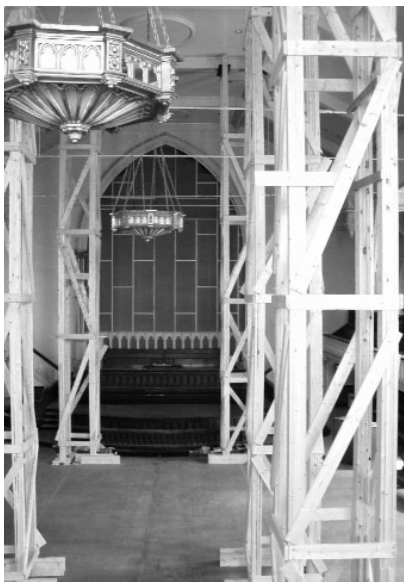
*With funding from the Landmarks Conservancy, massive shoring was installed from basement to roof to support failing trusses until repairs are completed.*

The Landmarks Conservancy helped in 2000 with a \$5,000 consulting grant to fund an engineering study, which showed the building was viable but needed shoring to stabilize the building, allowing time to fundraise for substantial structural and roof repairs. A \$10,000 grant went towards the \$55,000 costs for shoring. Total project costs are anticipated to be \$2.5 million, including architectural services, temporary shoring, and renovation. In 2003, the project received a \$30,000 Robert W. Wilson Sacred Sites Challenge Grant.

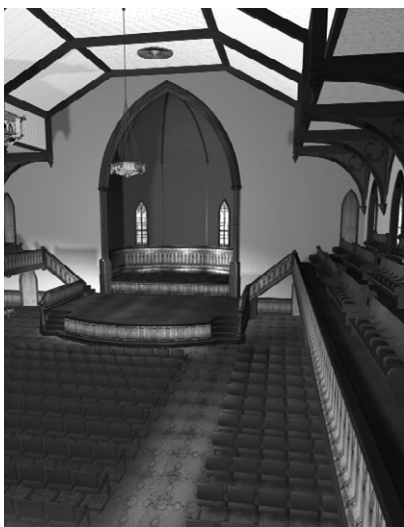
John G. Waite Associates Architects PLLC

*A computer generated rendering shows the huge capacity of the converted sanctuary.*

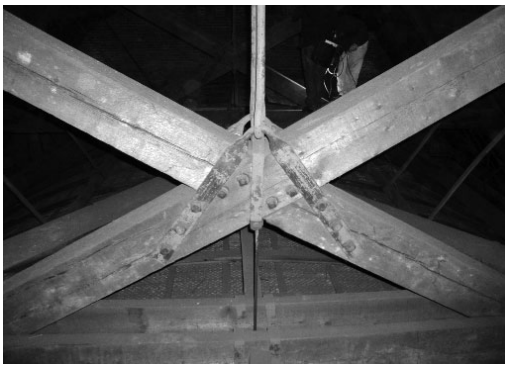
*The attic, with its massive wood truss beams, lack safe walkways.*

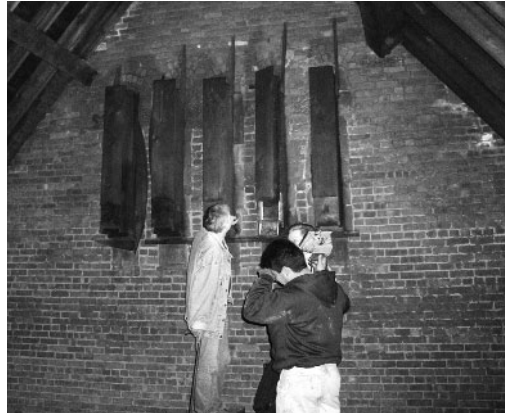
*Air baffles that were blocked with debris were cleaned during the restoration.*

The restoration project included cleaning and repair of the baffles, as well as the replacement of deteriorated lower panels with new lead-coated copper louvers. The pigeon population was evicted, and the missing hatch cover was replaced. Wood timbers were in generally good condition, but the beam connections were reinforced. New lighting even helped the team locate the original interior access: a barely visible opening from the intermediate attic above the organ loft, which had appeared to be a dead end. By crawling through this opening, it is possible to get from the church interior to all of the attic spaces, although not easily. The congregation was advised to install a better access ladder, so that routine inspections of the attic will be possible in the future.

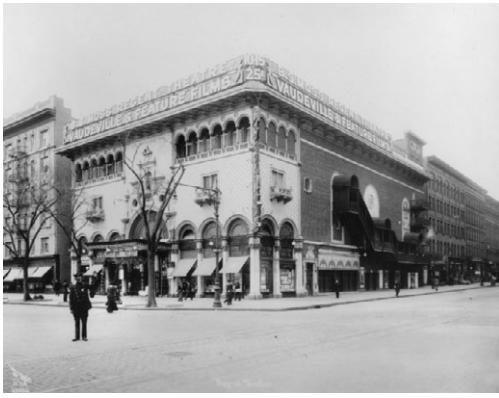
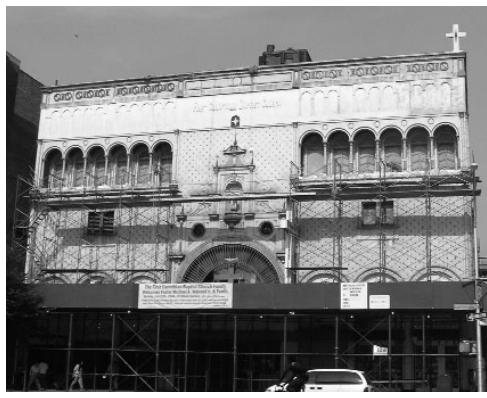
*Left and Center: First Corinthian Baptist Church in Harlem was originally constructed as a motion picture palace, with an ornate terra cotta facade. Its prominent corner location in a midrise residential neighborhood made it a desirable cell location.*

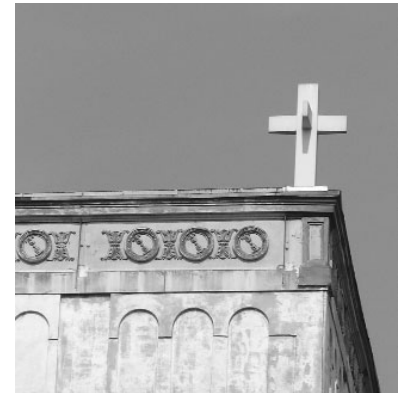
*Right: The metal rooftop cross was replaced in fiberglass to accommodate a cellular antenna.*

Meisha Hunter of the New York City Landmarks Preservation Commission said, "Most buildings have their own site-specific problem and corresponding solution." Cellular companies sometimes propose placing a cross on the steeple of a church for panel installation. Local and state preservation agencies often approve this, if the cross is appropriate to the scale of the historic building. This worked for the First Corinthian Baptist Church in Harlem, where the cellular company replaced the existing sheet metal rooftop crosses in fiberglass, making them slightly larger, but consistent with their prior appearance in color and proportions.

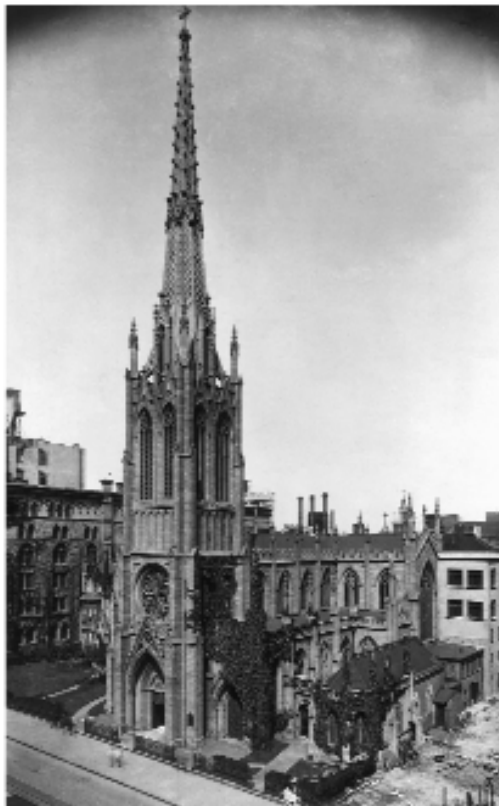
Grace Church of New York, Broadway at 11th Street

*after reconstruction, window tracery carving and replacement, sheet metal roofing*

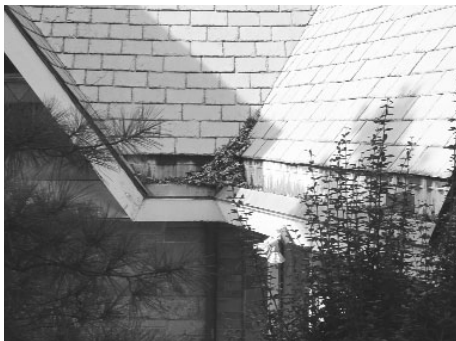
Walter Sedovic Architects

*Clean debris from drains, gutters, downspouts and catch basins.*

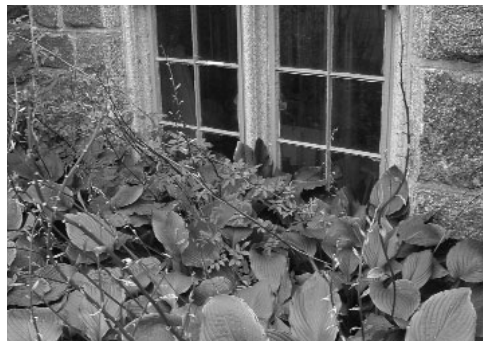
Walter Sedovic Architects

*Remove vegetation and root systems adjacent to building walls.*

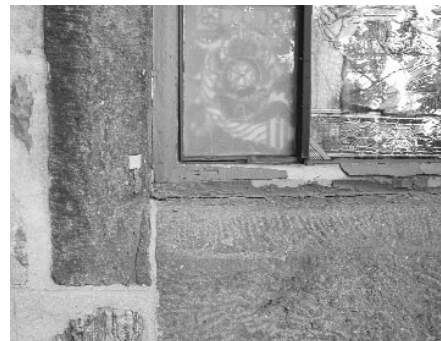
Walter Sedovic Architects

*Inspect windows for damage, and plan for repairs.*
