# Common Bond

In this Issue

Roof Restorations

# Copper & Terneplate: The Facts about Metal Roofing

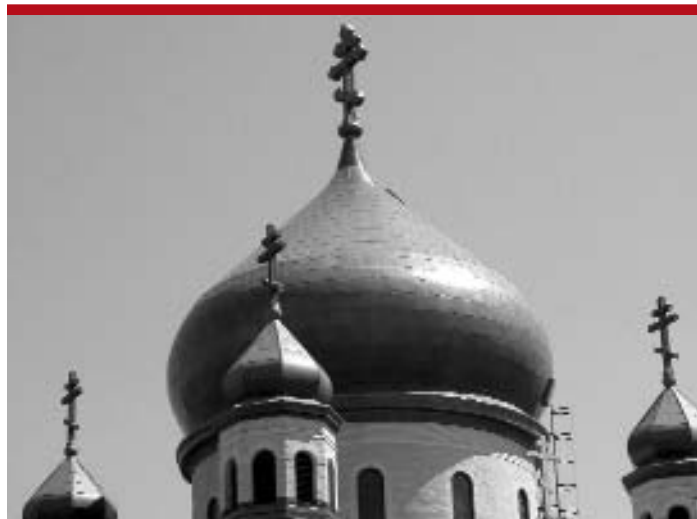
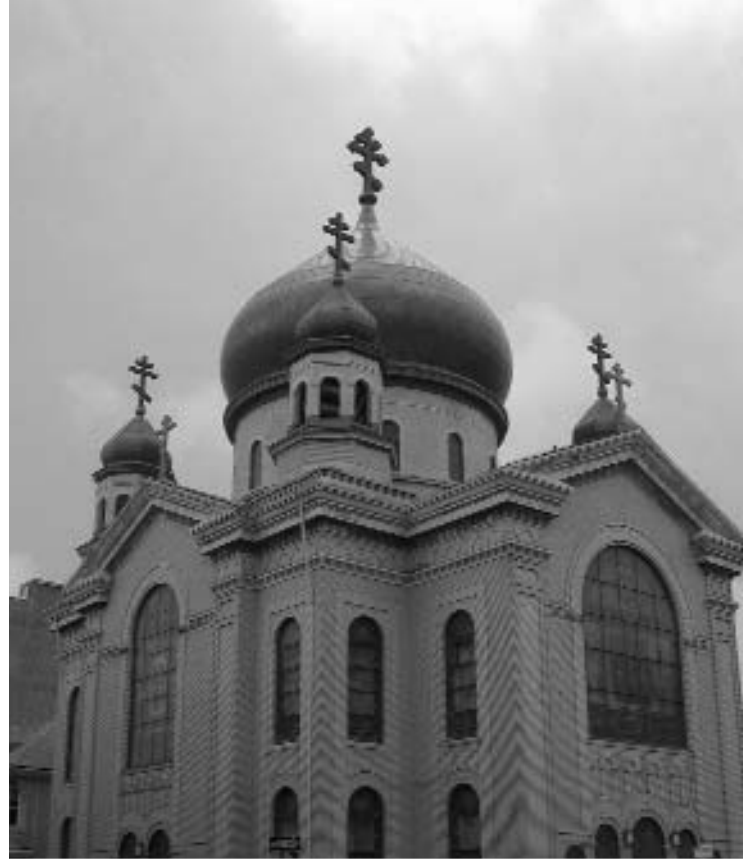
*above and below: The copper domes of the Russian Orthodox Cathedral of the Transfiguration of Our Lord in Williamsburg, Brooklyn were recently restored.*

## New Copper for Russian Domes

The Russian Orthodox Cathedral of the Transfiguration of Our Lord in Williamsburg, Brooklyn recently reclad its five copper onion domes. Designed by Louis Allmendiger to recall the Cathedral of the Dormition in Moscow, the Byzantine Revival - style cathedral was built between 1916 and 1921. It is a New York City Landmark. The recladding was part of a larger restoration that included refurbishment of the three-bar patriarchal crosses that crown the domes and repointing of the domes' brick octagonal bases. The Cathedral's recladding process exemplifies the use of different seams according to pitch and roof size.

The recladding of the domes was necessary because the century-old copper had been damaged by hail storms and was showing signs of wear. "The copper was in good condition but had microscopic holes in it," notes the project's contractor, Larry Plevy of Schtiller & Plevy, Contractors. These holes classify as pitting of the metal, which can range from being microscopic in size to up to 1/4 inch in diameter. Pitting will cause copper to have a yellowish gold color a result of the copper wearing thin.

The roofs on the four smaller 12-foot corner domes were installed using a system of vertical raised seams. The smaller diameter and more steep design of the corner domes meant that smaller pans of copper would have to be used. Notes William Stivale, the architectural conservator advising the project: "If flat seams had been used instead of vertical ones, we would have had to scatter the seams and ended up with a whole bunch of little seams."

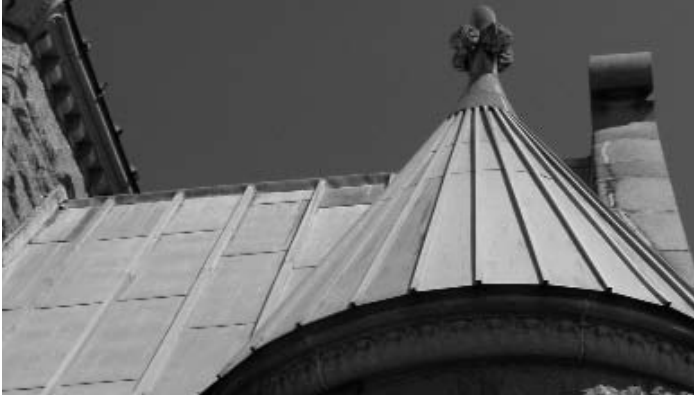
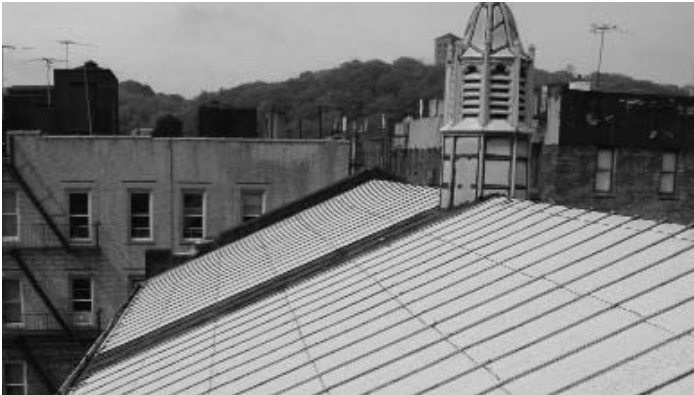
Using the appropriate seam profile is also important. The seam is the type of joinery commonly used to connect metal panels to one another.

A standing seam has an upturned portion that connects to adjacent metal sections and creates distinctive vertical lines by raising the seam above the drainage plane of the roof. These seams are held together by concealed clips, or cleats. Standing seams are generally specified for use on steeply-pitched roofs and in areas of high precipitation.

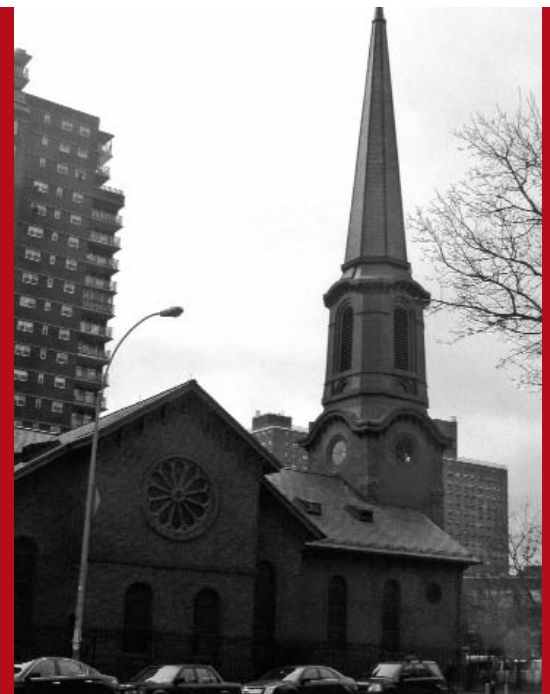
*above: The restored copper roof at Holy Apostles Church.*  
*below: A detail of the flat-seam copper panels.*

The Church of the Holy Apostle is both a New York City landmark and listed in the National Register of Historic Places. The history of its copper roof exemplifies how improper installation and inappropriate maintenance can lead to twisting and tearing of copper.

Its roof had originally been of wood but was replaced with copper at the turn of the last century. The copper roof had been installed with incorrect size panels and was through-nailed during later maintenance. The pans were too wide and the seams too closely spaced. This, coupled with the nailing, left the material without an outlet for its natural thermal expansion and contraction, causing seams to open and tear and the metal to buckle.

Because the ornamental detail varied from one piece of wood to another, the YSC crew worked daily making a pattern. The team cut and installed those pieces on site in order to match the the turn-of-the century original in design, workmanship, and appearance.

Completed in fall 2006, Holy Apostle's restored copper roof helps the landmark shine in its urban setting of Manhattan's Chelsea neighborhood.

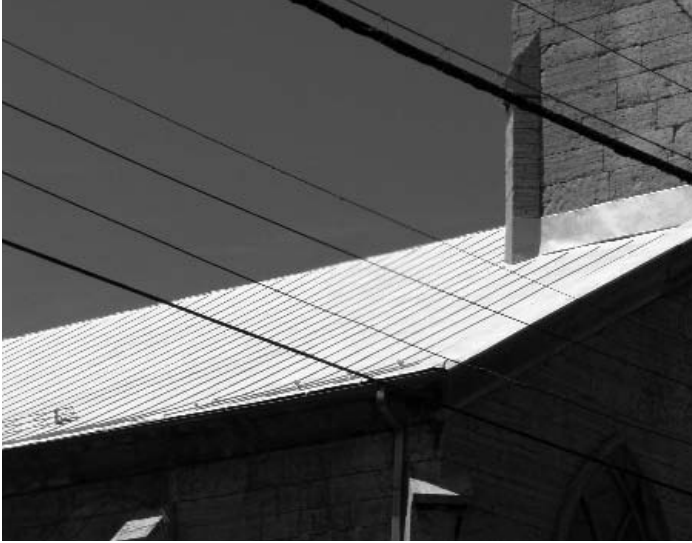
*Fair Street Reformed Church in Kingston, NY replaced portions of its terneplate roof with a modern version of the material.*

One of her former projects, Fair Street Reformed Church in Kingston, New York, recently repaired and recoated its 1934 terneplate-steel roof;

small portions were replaced with a modern version of the material. Built in 1850 and designed by Thomas Thomas, Fair Street is an imposing Gothic Revival structure constructed of locally-quarried limestone. The church had received a consulting grant from the Sacred Sites Program for the development of plans and specifications. The roof restoration and other associated restoration work were financed with the help of a \$25,000 Robert W. Wilson Sacred Sites Challenge Grant from the Conservancy in 2002.

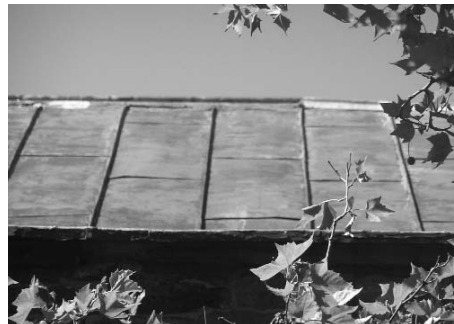
*Christ Church in Cobble Hill, Brooklyn, has a standing-seam steel roof.*

Standing-seam steel is a popular metal roofing option. Steel can be painted any color and is available with factory-applied coatings, similar to paint. Aesthetically appealing, these coatings protect the metal panels and can also help keep a roof cooler.

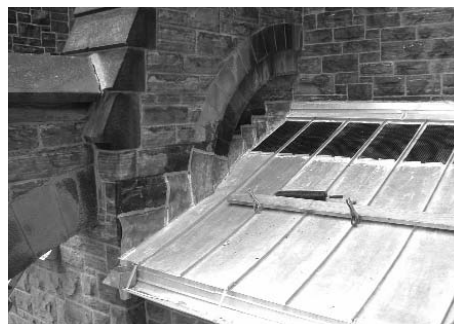
*Episcopal Cathedral of All Saints in Albany, NY has a standing-seam, terne-coated, stainless steel roof.*

Terne-coated stainless steel has become the preferred replacement for historic terne roofs, because of its relatively lower maintenance. It will not rust or corrode and weathers to a natural matte-gray finish, but it is expensive.

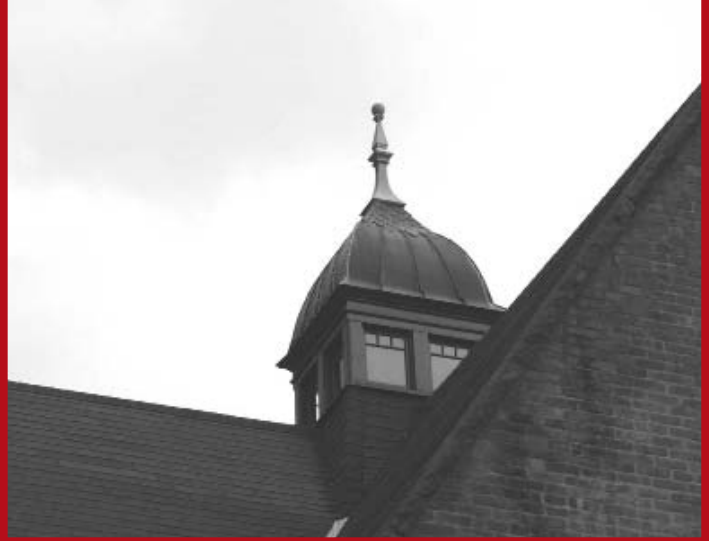
The construction documents were amended to specify standing-seam copper flat pan for the main roof, as well as to replace the damaged slate roof on the steeple. This solution resolved the water drainage problems in a historically appropriate material.

According to Waite's Project Manager, Michael Curcio, the copper roofing installation is a specialty and must be carefully implemented. Before beginning work at St. Paul's, his firm asked the roofing contractor to do a sample of the copper seams being used, which was then used as a model. Detailing is important, he notes, because of the material's propensity for expansion and contraction. The slope of the roof dictated where raised seam would be used; soldering would be used on flat portions of the roof.

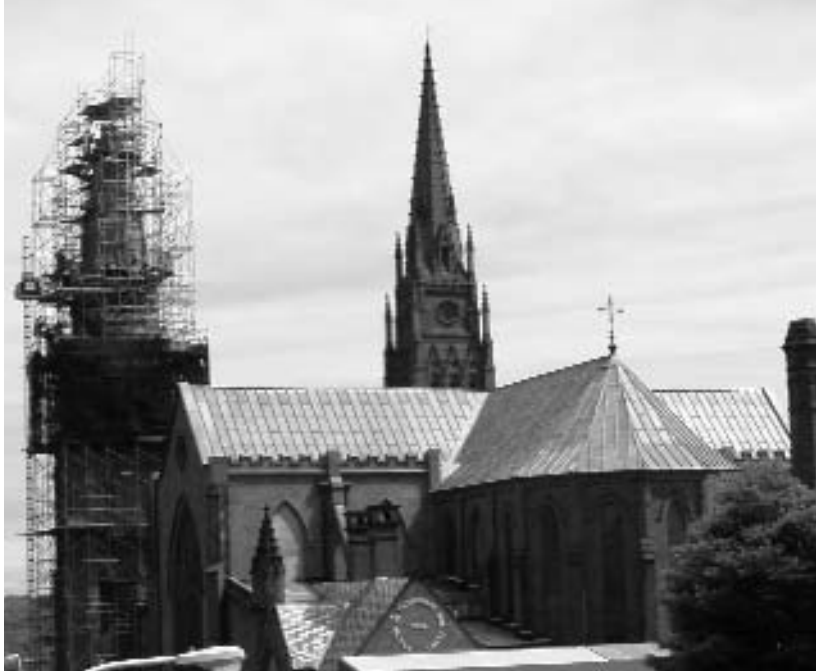
Located just south of Capitol Hill in downtown Albany, New York, the Cathedral of the Immaculate Conception is the third oldest cathedral in the U.S. It was built from 1848 to 1852 by architect Patrick Charles Keely. An excellent example of American Gothic Revival ecclesiastical architecture, the brownstone building features Gothic-arched entrance portals and windows and twin towers that stand 210 feet high.

Historic photographs, as well as investigation of the trusses, confirmed this theory. "The purlins within the attic had water stains on them in a constant pattern, roughly 24 inches apart," Baker recalls. (Purlins are horizontal timbers supporting the roof rafters.) "This kind of failure is easily explained [ if there ] was indeed a standing seam metal roof on the building. The seams failed, allowing water to enter the attic and stain the purlins in the pattern we observed." Once the slate was removed, the exposed roof deck showed clear signs of a previous metal roof with standing seams set 24 inches on center.

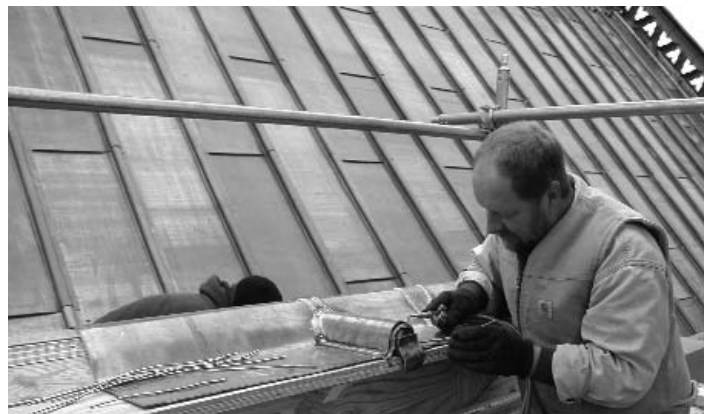
*Crews installed the new lead roof with rolled seams at 24-inch intervals.*

intervals. The lead leader boxes, where water is collected and conducted to downspouts, were manufactured by Chris Bailey of El Dorado Metals in Arkansas. (see below)

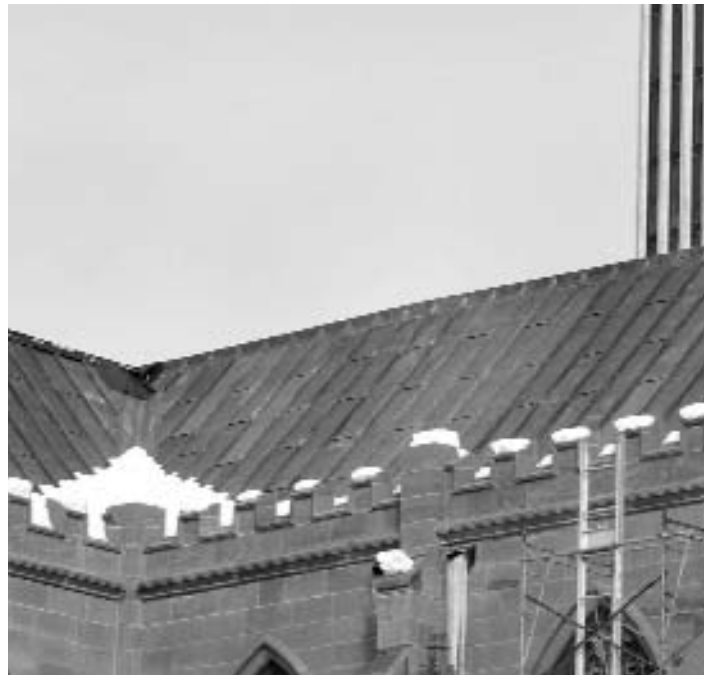
*The Cathedral's lead roofing, drainage system, and re-created crenellated parapets were installed in 2002.*

The opening in the wall that allows the roof drain through is known as a scupper. Leader head boxes collect rainwater from the roof gutter via the scupper, connecting the horizontal gutter to the vertical leader. The leader then conducts the rainwater down to the ground and away from the building, or to a sub-grade storm drain.
