Common Bond

Vol. 22, No. 2 Autumn 2008

Testing Your Metal	1
Cleaning Marble Statues	4
Marble Decay and Erosion	6
Marble in (and Around) the City	7
Marble Collegiate Church	8
Religious Heritage Survey	10
St. Saviour's Rescued	10
2008 Sacred Sites Grants Awards	11

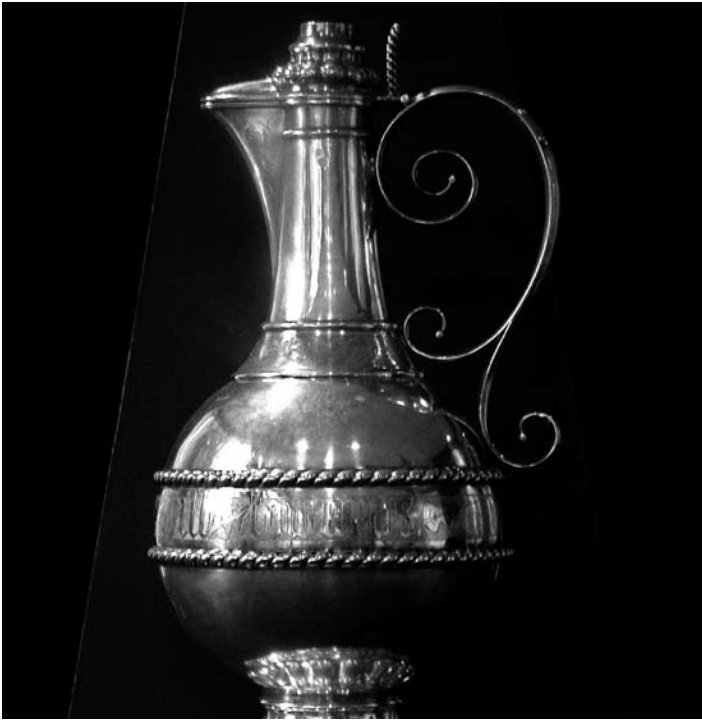
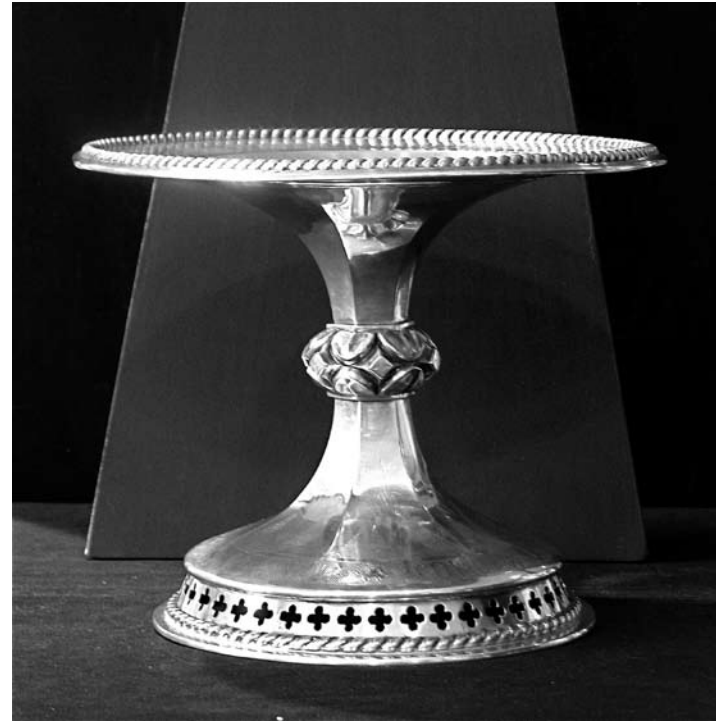
From the Church of St. John in Manhattan, a large Eucharistic flagon and a footed paten, used to consecrate bread.

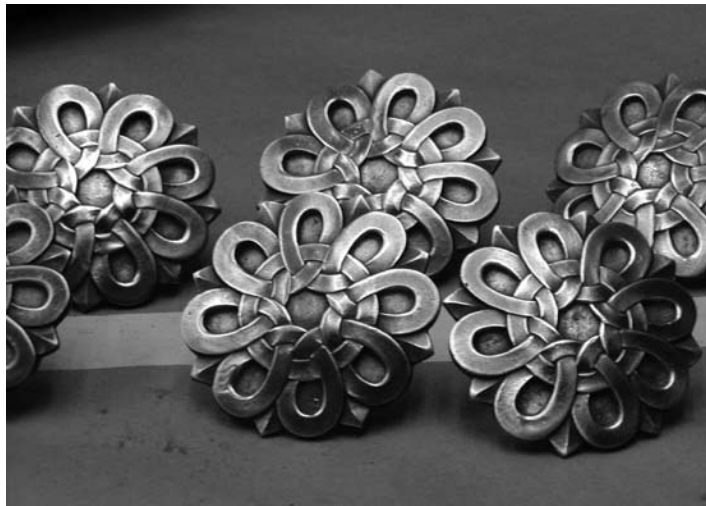
Rosettes on Manhattan’s Temple Emanu-El vestibule wall were removed and restored to match their original appearance.

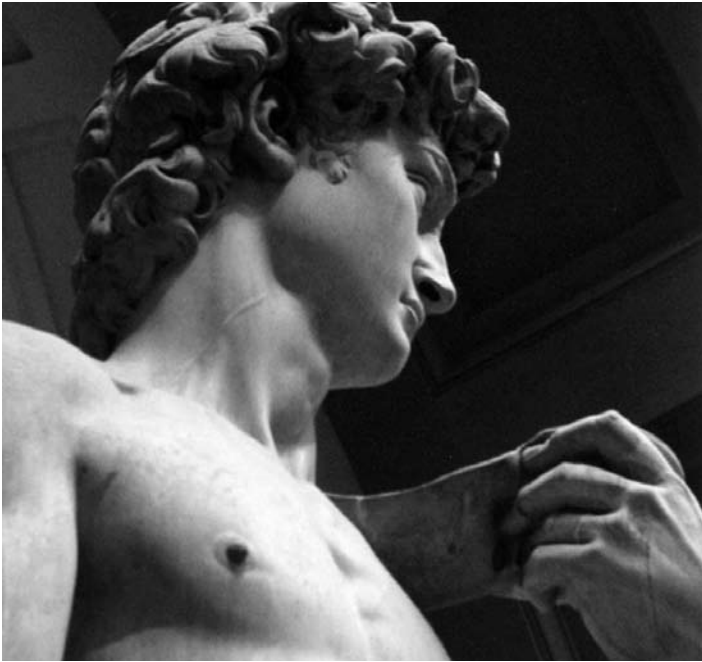
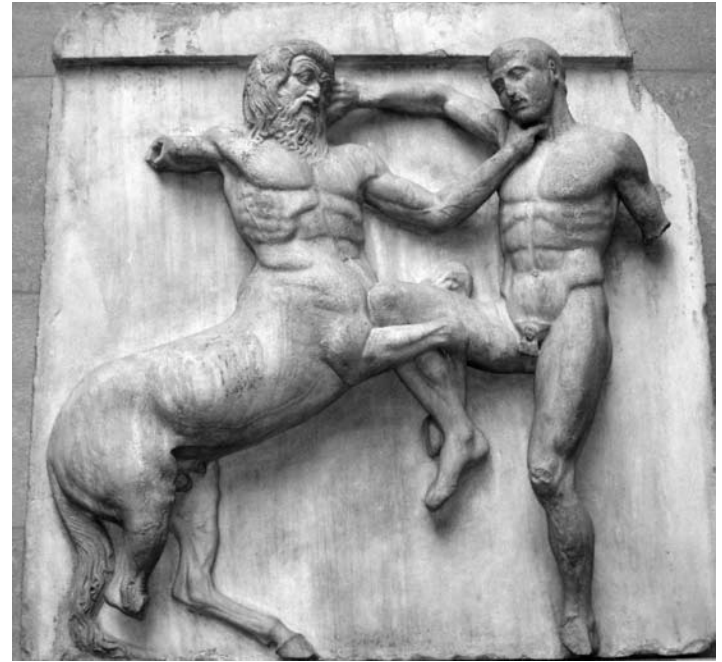
Left To clean Michelangelo's *David* in 2003, a poultice of distilled water and cellulose fiber was used, a method that caused controversy among art conservators.
Right The Elgin Marbles, housed in London's British Museum, have been damaged over the past century by pollution, necessitating frequent but careful washings.

a poultice of distilled water and cellulose fiber was used. Agnese Paronchi, the specialist originally contracted to complete the work, resigned from the job in protest, stating that this method was too harsh and could potentially damage the marble. James Beck, an art historian at Columbia University who opposes most intervention on historic works of art, led an international call for a conference to discuss other cleaning methods that might be used. In the end, conservators also felt it necessary to clean off a build-up of wax on the sculpture using white spirits (a common solvent), a move that did little to appease those who objected to the use of the poultices.

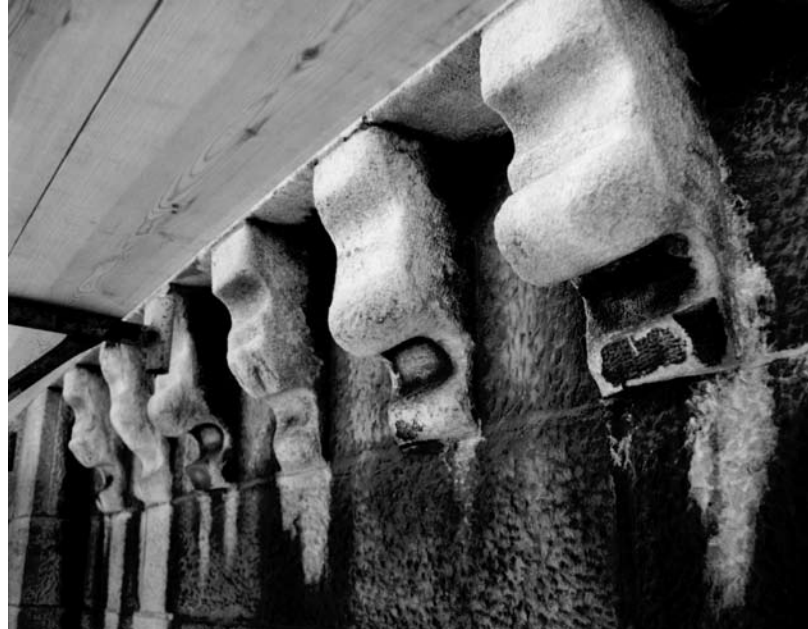
Because marble is soft and easy to shape, it is often used for decorative carved elements. But its chemical composition makes it vulnerable to acid rain, and the stone reacts with pollutants in the urban environment, which can cause erosion and sugaring (deterioration of a stone surface, giving it a granular appearance). Gypsum, a dense black crust, also forms on marble surfaces as the stone reacts with atmospheric sulphates. This crust is tenacious and usually destroys the surface on which it forms. Removal of crusts typically exposes surfaces devoid of tooling and ornament. Local microclimates often create areas around structures that require specific attention to prevent gypsum crust formation.

Meanwhile, the deterioration of metal cramps (steel or iron anchors tying the stone to the underlying structure) often causes spalling, as the corrosion and expansion of the iron or steel pushes against the stone in which it is embedded, causing the stone to crack, displace, and fragment. Structural movement (building settlement, failed beams, etc.) also typically results in movement of the exterior walls.

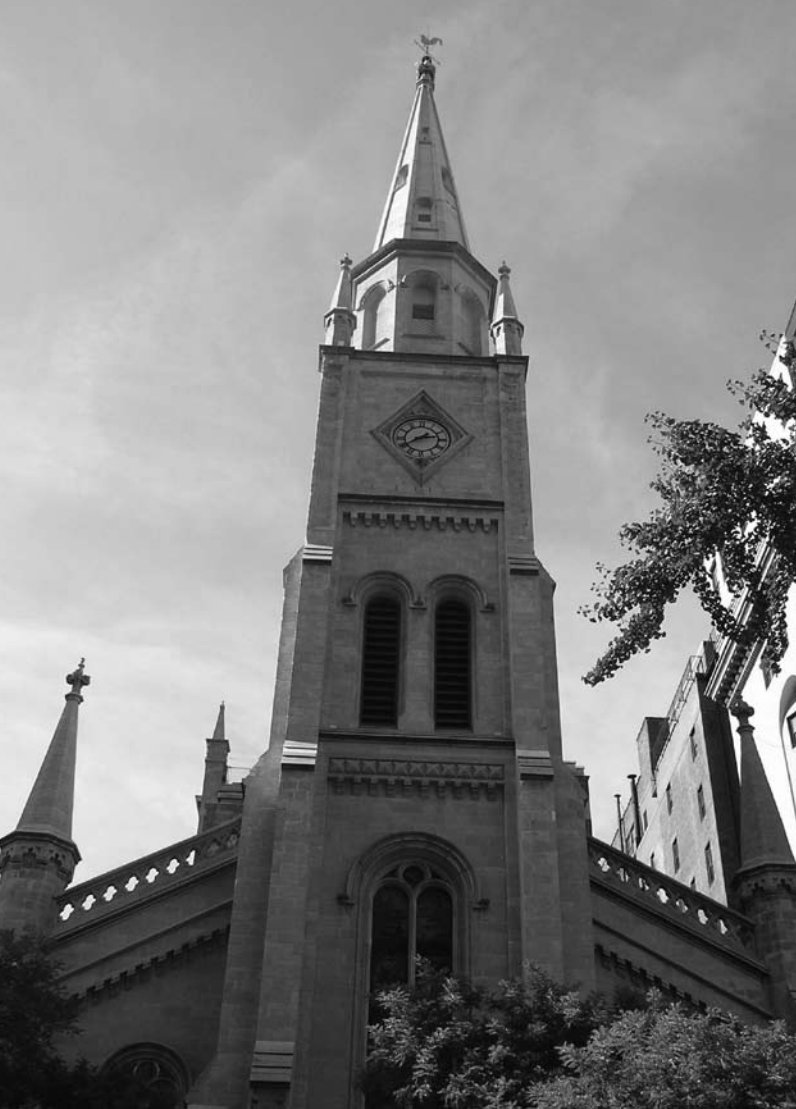
Restoration in the late 1990s of Manhattan’s Marble Collegiate Church (constructed in 1854 with stone supplied by the North River quarry in Hastings-on-Hudson) began as a simple project to clean the façade. Following a full conditions assessment including binocular surveys and an inspection of the steeple, it developed into a full restoration of the building envelope.

Maintenance records were not clear about the last major work on the façade. It wasn’t until scaffold access allowed us a close-up inspection of the walls that we found cement patches that provided dates of the last two major repair campaigns — 1908 and 1952.

The mortar in many joints was severely deteriorated and, in some cases, missing. Due to the joint conditions, we established a two-part pointing procedure. All mortar joints were cleaned of dirt and mortar debris and back-pointed prior to the building cleaning. Finish pointing was completed after the water wash to insure joint faces were located behind the edges of the stone.

In addition to the mortar joints, all of the finials were disassembled. We found severely corroded steel cramps and reinforcing. The finials were reconstructed with new stainless steel reinforcing. Small replacement stones were inserted in locations of severe stone deterioration.

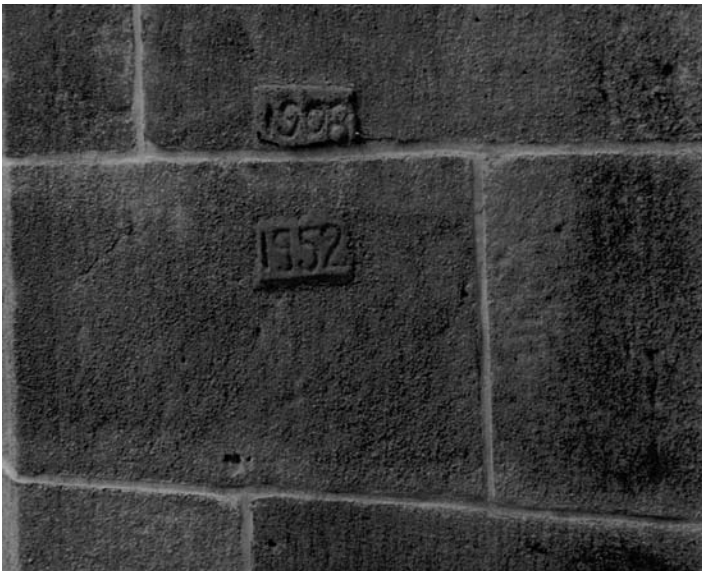
A close-up inspection of the church's walls revealed cement patches showing dates of the last two major repair campaigns — 1908 and 1952.

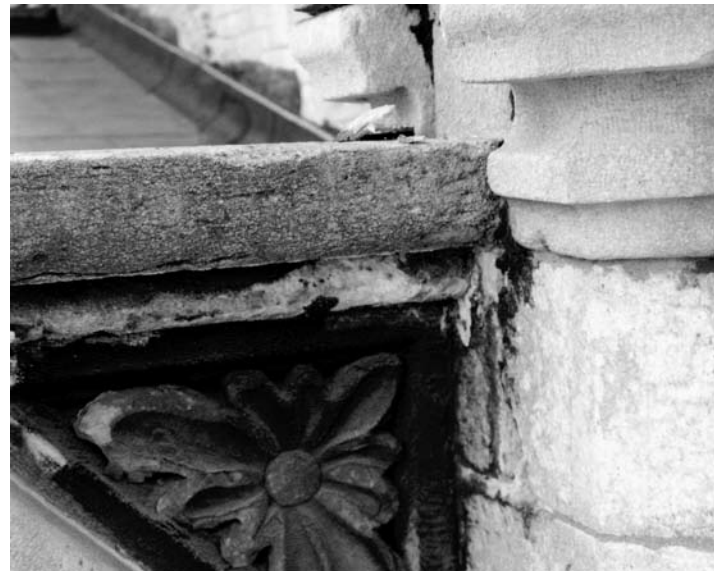
Floral motif with gypsum crust and staining, prior to cleaning.

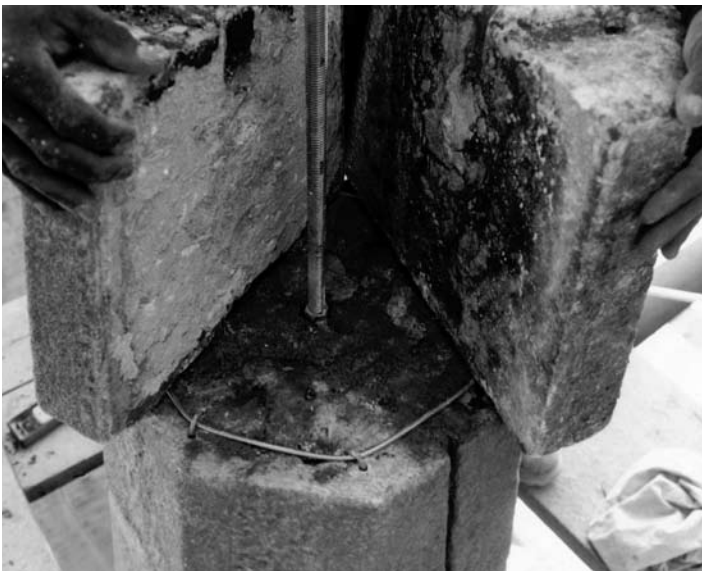
The finials were disassembled and reconstructed with new stainless steel reinforcing.

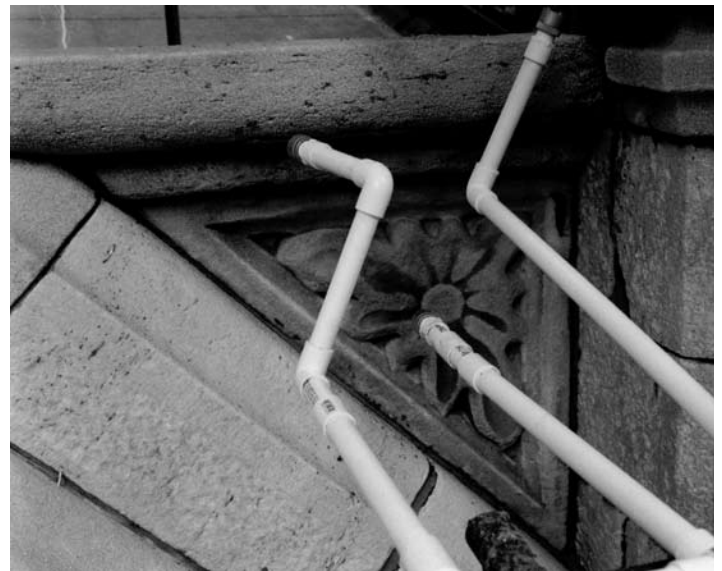
Numerous cleaning tests were conducted with different products that minimized water usage. Nothing worked quite as well as water.

Although we knew that water was probably the best means to clean the stone, the project was complicated by a two-year drought and water restrictions. We conducted numerous cleaning tests with different products that minimized water usage. But we had very limited success and found that water worked best. After cleaning the façade the following year with a water wash, we treated excessively stained stones with chemical poultices. The poultices lightened the staining, minimizing the aesthetic effect, but did not completely remove the stains. Work was completed in 2000.

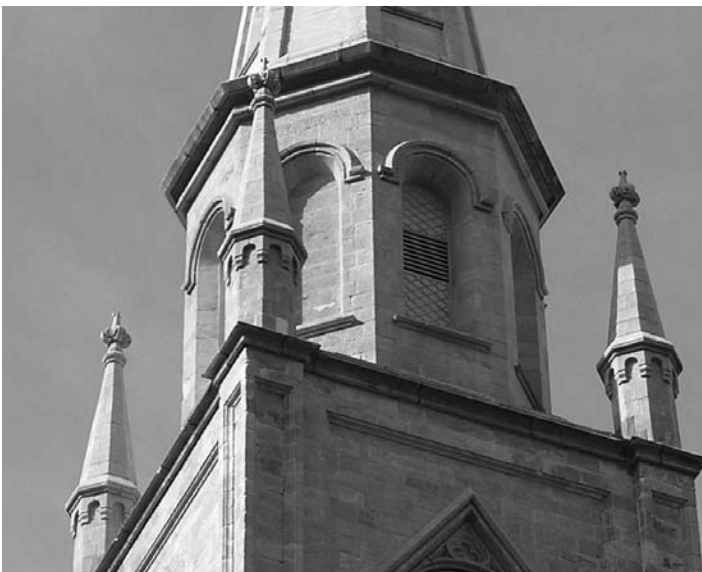
The reconstructed finials

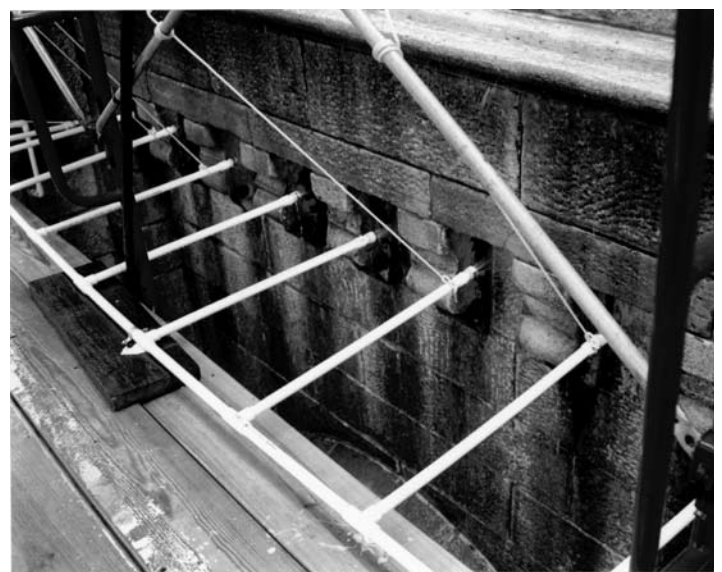
A network of pipes directed water to heavily stained areas.

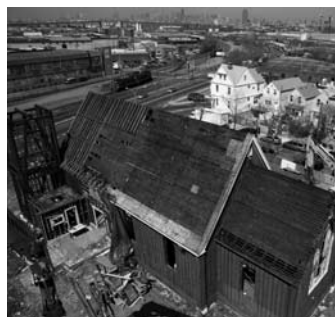
Left: Unfortunately, narrow street widths and overhead bridges and utilities precluded moving the church to its new site without first dismantling it.

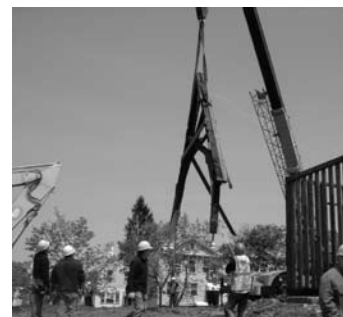
Right: The monumental trusses were removed with a crane.
